Hazard Mitigation Works in Bayfield County to Prevent Damage

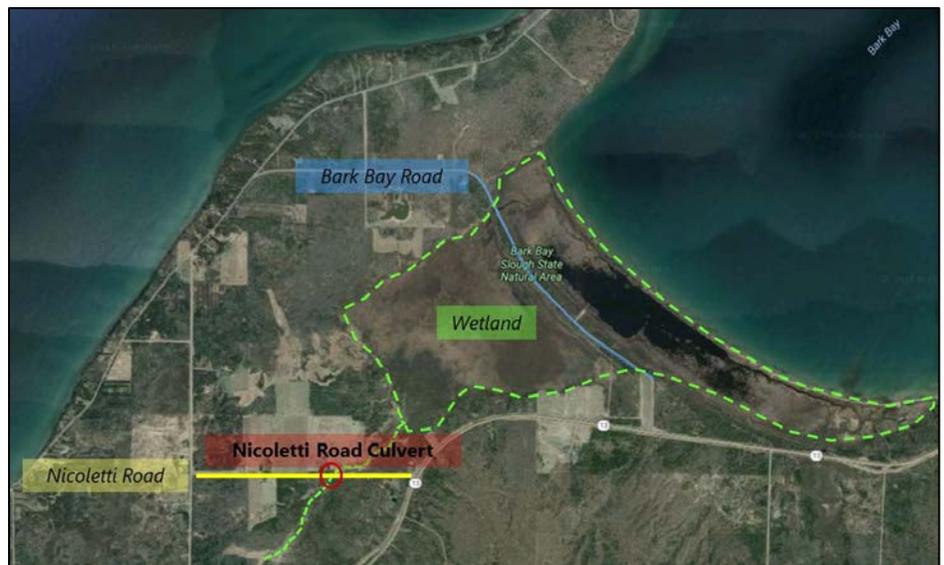
When the Horseshoe Creek in Bayfield County floods, it sometimes causes the closure of Nicoletti Road. It is not only an inconvenience for motorists but was also a safety concern since a road washout could become an obstacle for first responder vehicles. That’s why the Town of Clover decided to take action and develop a hazard mitigation strategy to replace a culvert with a larger one that would help alleviate flooding issues.

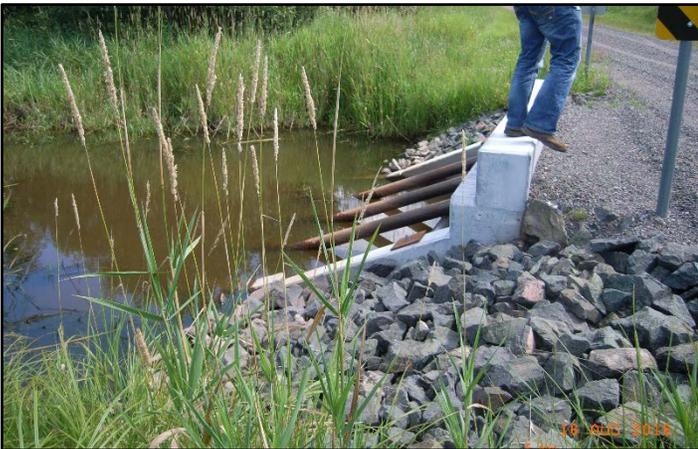
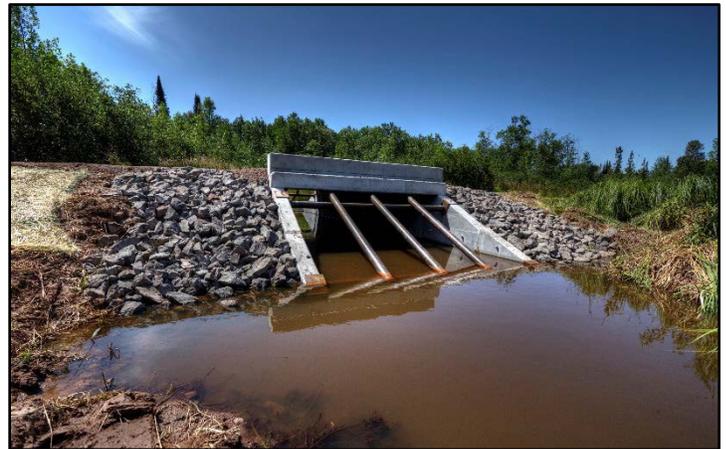
Road damage during the storms stopped short of the culvert mitigation project; the upsized culvert was able to handle the runoff from this event, and Nicoletti Road at Horseshoe Creek “held beautifully,” according to Beverly Steele, Town of Clover Chairperson. Although the Horseshoe Creek culvert was a success, Steele stated the washout on the other part of Nicoletti Road indicates that “further mitigation is needed.” Recently, hazard mitigation projects have helped prevent damage by replacing small culverts with larger ones that could handle heavy water flow during major storms.

During the July 11-12, 2016, storms, three to four inches of rain fell on the Town of Clover in a 24-hour period. Many roads and culverts in the area washed out, including part of Nicoletti Road to the east of the culvert mitigation project. At this point of the road, 11 streams from the hills to the south drain into a ditch on the south side of the roadway. During the storms, this ditch filled beyond its capacity and overtopped Nicoletti Road, resulting in a quarter mile of roadbed erosion and subsequent closure of the road. While numerous roads were washed out and damaged during the torrential rain that fell in northern Wisconsin in July, the enhanced Nicoletti culvert performed as expected and damages were prevented due to the HGMP project.
