# FEMA

## Mitigation Project Reunites A Town Divided

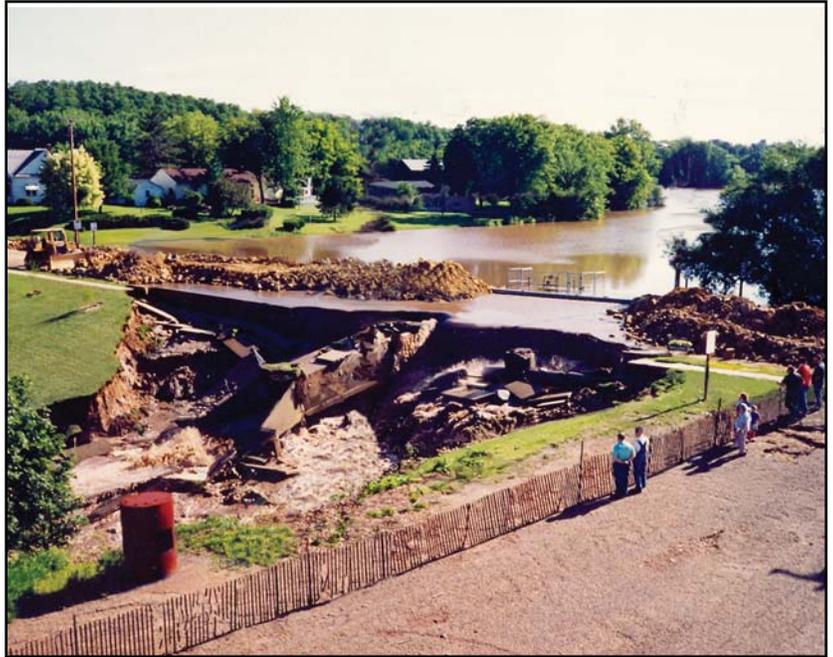
*The day after a flood washed out the road over the dam in Cambria (May 1993), residents are astonished at the sight of the destruction.*

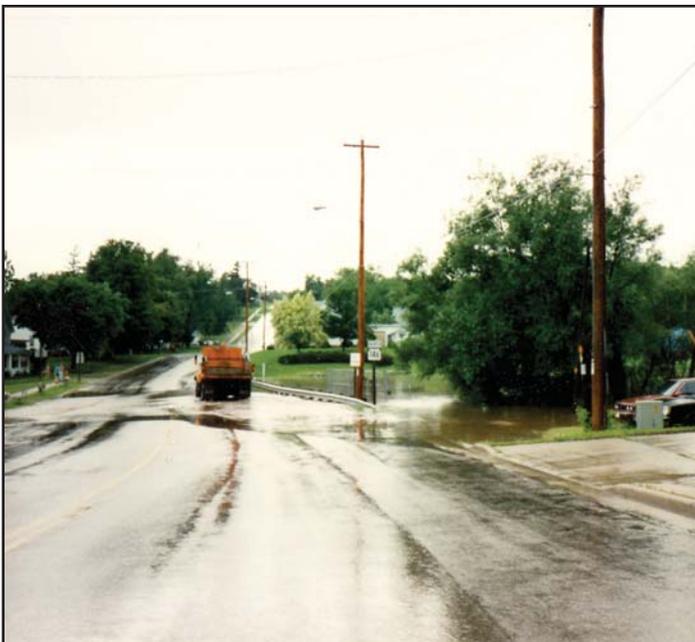
*Tarrant Lake (to the right of the road) begins to overflow its dam during heavy, persistent rains in late May 1993.*

In 1993, the Cambria Dam suffered a major washout. Damage to the old earthen construction was extensive.

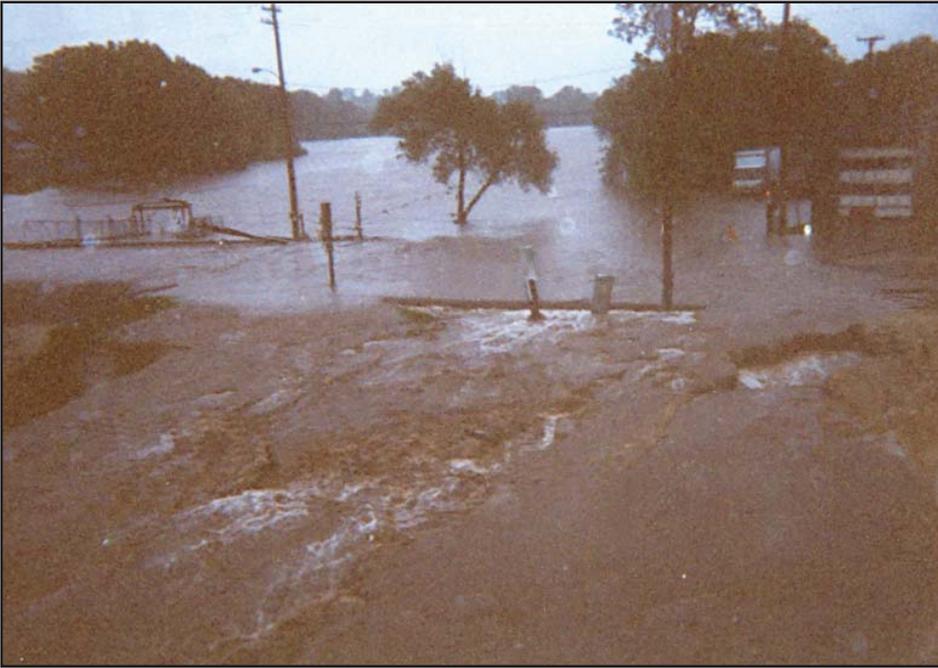
*As darkness falls on June 9, 2004, just eleven years after the previous major flood in Cambria, water from Tarrant Lake crests over the dam and begins to erode Wisconsin State Highway 146 once again. Photo: courtesy of Town of Cambria*

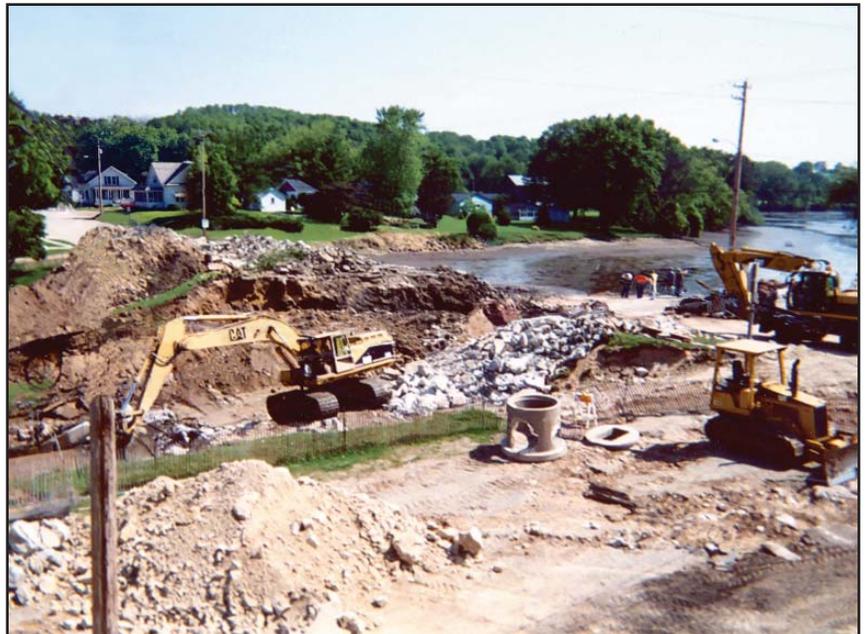
*Cleanup and new construction on new dam begins in September 2005. Photo: courtesy of Town of Cambria*

Massive amounts of rock and gravel were used to fill the washout. A pile driver worked for several weeks pounding wide slabs of lapped steel into the earth on the lake side of the roadway. Tons of muck and debris were scooped out and trucked away to prepare a foundation bed for the new dam. Forms for concrete were put in place and concrete was trucked in and poured. Finally, the new sliding gate was set into place, while massive amounts of concrete were poured on the opposite side of the road to harden that area.

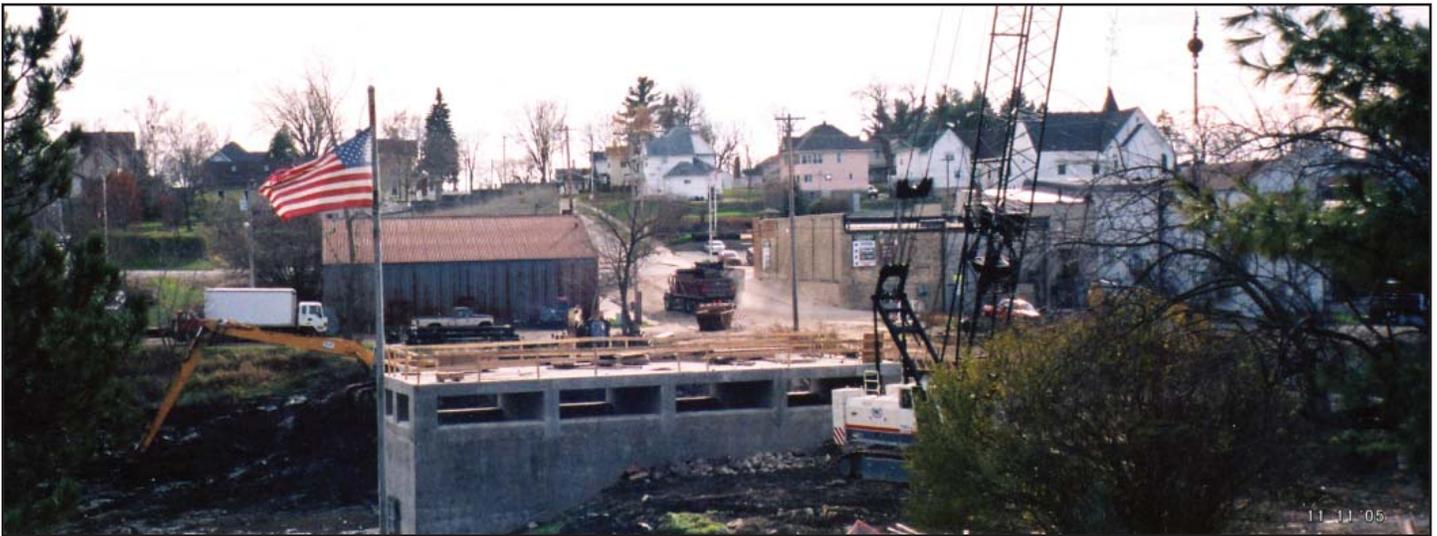
*The new dam, a perimeter weir overflow system type, nears completion. Tarrant Lake was drained, with its feeder streams and springs diverted around construction for two summers during the work. Photo: courtesy of Town of Cambria*

Construction on the project began on September 29, 2005. The result of the project was one main structure with integrated overflow discharge capabilities. The structure was almost entirely concrete with a lower mechanical gate and a perimeter-weir overflow system. This system was integrated into the roadway, with discharge water flowing under the road through a dual box culvert.

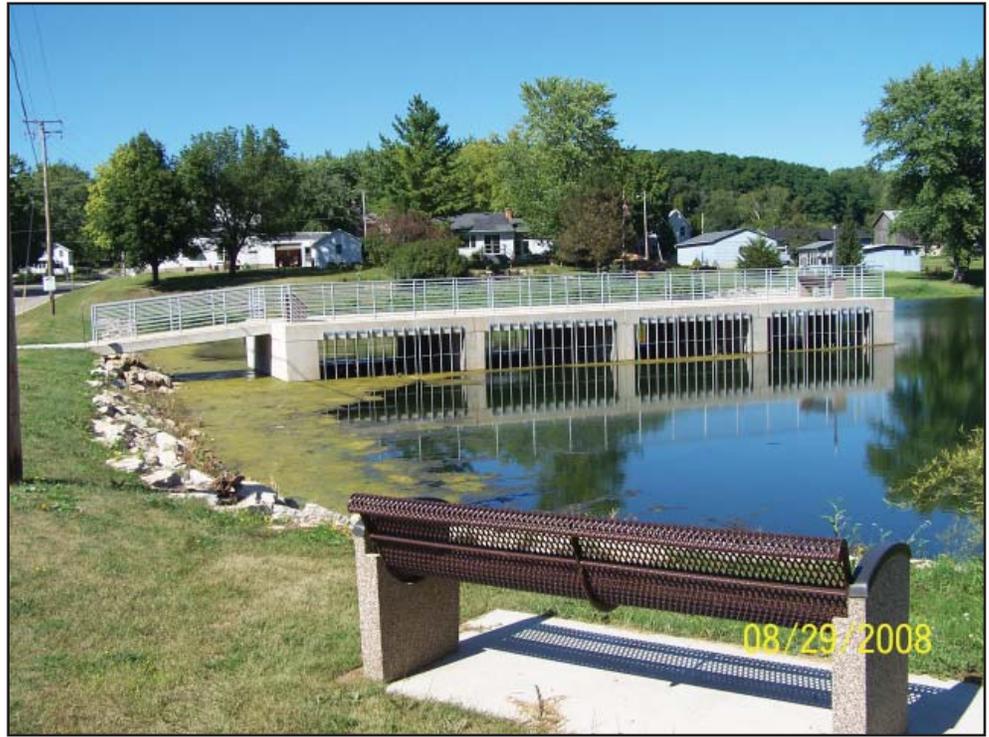
*The new perimeter weir overflow system provides an outlet for Tarrant Lake waters. Debris gates over openings on the sides facilitate easier removal of debris. The perimeter weir design helps prevent pressure on the dam itself during high water by allowing the water to pass through the concrete structure. Photo: Barbara Ellis, FEMA*

In addition to human intervention during the storm of 2008, the design of the new dam helped to prevent a repeat of the 2004 washout. A *weir dam*, also called a perimeter weir overflow system, it is composed of a large concrete box (weir) constructed perpendicular to

the old dam with openings on all sides into which the water flows from the lake under the road through the dual box culvert. The openings are covered with debris guards. This design reduces water pressure on the earthen berm dam.

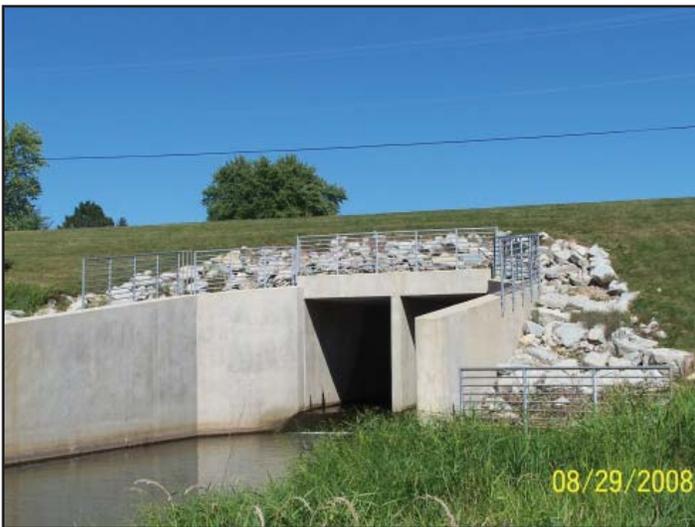
*A dual box culvert provides an outlet for Tarrant Lake under the highway and into Duck Creek in Cambria, Wisconsin.*
